NDIA E2S2 Symposium New Orleans, LA. (May 9-12, 2011)

A Sustainability Approach to Upgrading Corroded, Inoperable or Difficult to Open Fire Hydrants via an Off-the-Shelf Stainless Steel Retrofit Kit

Engineer Research and Development Center/
Construction Engineering Research Lab

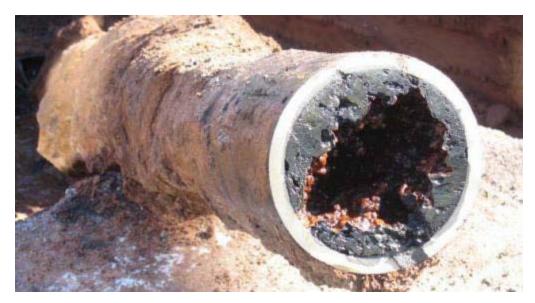
Tuberculation in 6-inch Unlined Water Main

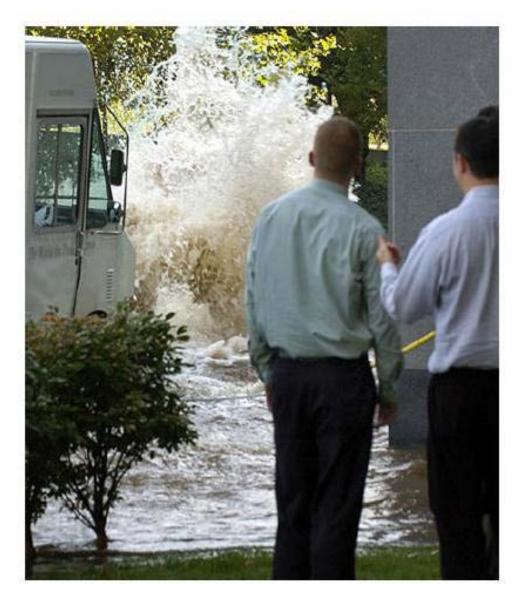
36 Inch Main Break

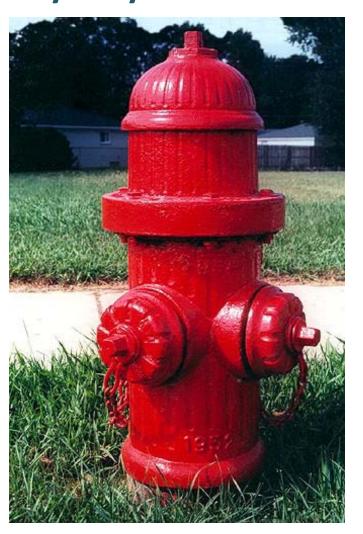
Standard Dry Barrel Fire
Hydrants Have Cold-Rolled
Steel Stems Which Can
Corrode
